S-300 Eastern Shore National Bank Crisfield public

c. 1900

## Maryland Historical Trust State Historic Sites Inventory Form

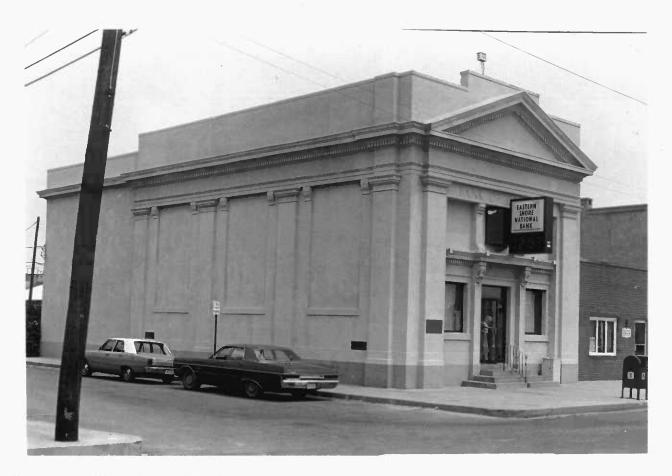
Southeast Elevation

The southeast (main) facade is a classically inspired temple-front design with corner pilasters topped by a classical pediment. The Doric order pilasters frame the center door opening, which is elevated on a three-step granite platform. The door is flanked by paneled columns with acanthus leaf capitals, and to each side of the columns are single-pane windows. Atop the capitals, a molded cornice with a dentil row divides the entrance bay from the upper portion of the first floor which is now blocked up. This upper portion is divided into three sections and split by short, simply molded columns. A modern bank sign for "Eastern Shore National Bank" occupies the center bay. Engraved in the stone above this modern sign is the old name "Bank of Crisfield." The classical pediment follows a combination of Roman Doric pilasters and a Roman Ionic frieze. The dentil work under the cornice was continued within the pediment. The tympanum is plain. Rising above the pediment is a stepped parapet finished with a slightly projecting cap.

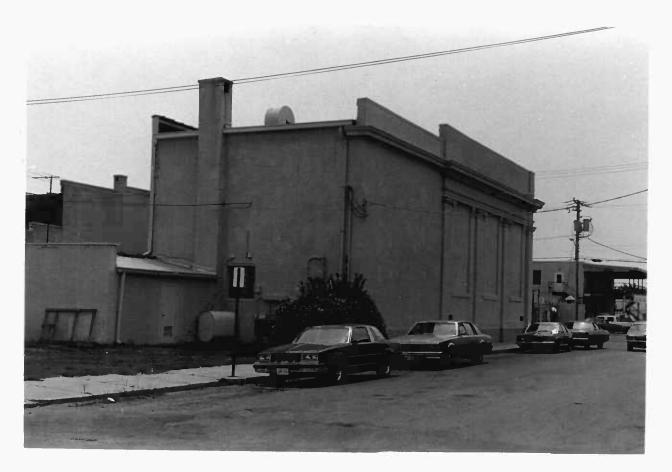
Southwest Elevation

The southwest street elevation is a partially decorated facade divided into three principal bays. Four Doric pilasters separate three blind bays, while the Roman Ionic entablature extends around from the front. Attached to the main block is a simply finished rear bay which is a plain stuccoed wall joined visually to the front block by a continuation of the molded cornice. The parapet is slightly shorter than the main block.
